List of WSDOT Elements by Number

4-1 Introduction

This chapter defines the Washington State Department of Transportation (WSDOT) approach for inspection, evaluation and recording of the structural condition state of the bridge structures within the WSDOT obligation to the National Bridge Inventory.

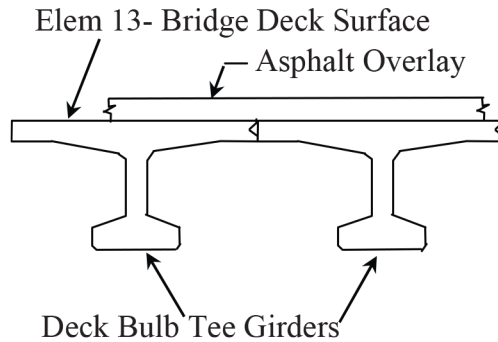
WSDOT BMSE	Prior BMS	Bridge Deck Surface - Top Flange	Units - SF	NBE	BME	ADE
16	13			16	--	N

This WSDOT element defines a surface of a bridge deck that consists of a slab or girder without a traditional deck. Usually there is a deck protection system (overlay) present, but in some cases, traffic may be driving directly on the girder or slab. The Bridge Deck Surface consists of precast or prestressed girders with no span between the flanges. This WSDOT element is generally used with superstructure elements 38B, 38D, 39B, 39D, 54, 109E, 109F, or 110B. The total quantity for this element is the actual bridge deck area from curb line to curb line.

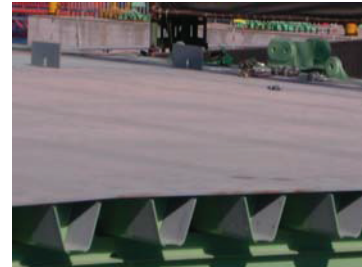
WSDOT BMSE	Prior BMS		Units - SF	NBE	BME	ADE
30A	27	Steel Orthotropic Deck		30	--	Y

This WSDOT element defines a bridge deck constructed of a flat, deck plate stiffened either longitudinally or transversely, or in both directions. See BIRM, Volume 1, Figure P.1.2.7. The total quantity for this element is the actual bridge deck area curb-to-curb.

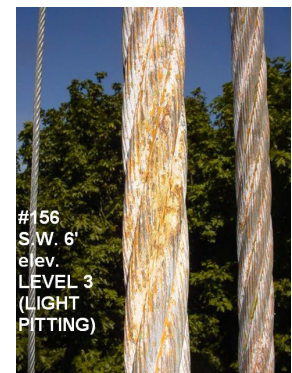
3. Number of cables or anchors with defects that are beginning to affect the capacity of the cable but are within acceptable design limits. Localized areas of zinc depletion and showing rust spots, but there is no visible section loss. Cable stay protective polyethylene pipe has cracked and separated, exposing grout or cable wires/strands. No corrosion present in exposed wires/strands.

4. Number of cables or anchors with defects that have clearly affected the capacity. This includes broken wires or localized section loss due to other defects. The zinc protective coating is largely depleted with ferrous rust prevalent in many locations along the cable length.

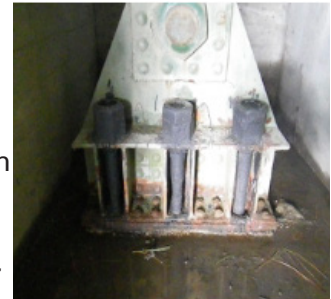
This is a NSTM of the bridge that carries uplift loads from the superstructure to the substructure. The anchorage may consist of several parts with built-up steel members. Each location has anchor bolts in tension that must be evaluated and included in the NSTM Report. The element is defined as all parts in tension between the lower tip of the anchor bolts to the first pin or truss member. A pin is usually present and included in element 161B because it carries uplift loads. The total quantity for this element is the number of Tension Hold-Down Anchor Assemblies on the bridge.

WSDOT bridges known to have Tension Hold Down Anchor Assemblies are: 2/35, 20/204, 25/130, 169/8, 261/125, 305/10 and 395/545.

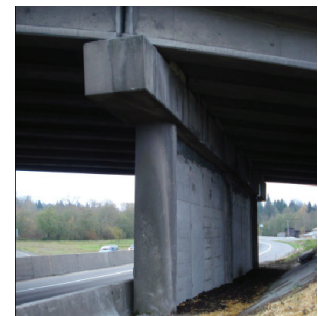
WSDOT BMSE	Prior BMS	Seismic – Longitudinal Restrainer	Units - EA	NBE	BME	ADE
370	370			--	--	Y

This element is used to identify longitudinal seismic restrainers. When an in-span hinge separates two structures, the joint, bearing, and seismic restrainers at the hinge will be documented in the dependent (or supported) structure only. The quantity should equal the total number of longitudinal restrainers on the bridge.

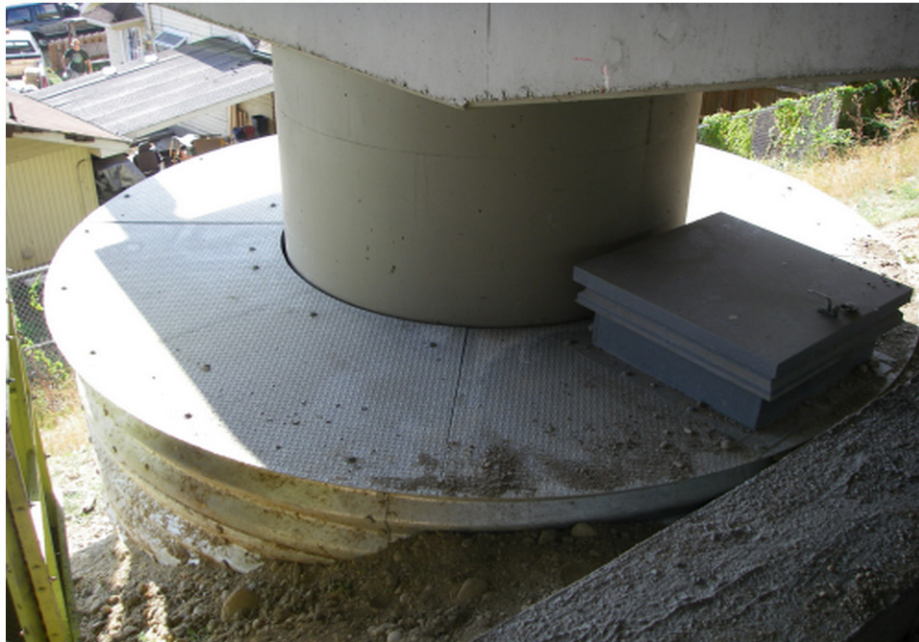
I-5 N-N RAMP OVER I-5 - 5/628N-N - 0016991A

This element is used to identify when a column has been designed to be isolated from the surrounding soil during a seismic event. This will usually consist of a corrugated metal pipe buried in the ground with a cap at the base of a column. The inspection note needs to identify the individual columns that are siloed along with the planned depth (relative to an identifiable elevation) at each one. In cases with small numbers of siloed columns, that could be done in the note. In other situations, a spreadsheet attached as a file or something similar may be useful. In-depth inspections are required upon the occurrence of a seismic event that is judged to have potentially affected the structure. Due to the dimensional variation of the column isolation feature at each structure, the In-depth inspection may require means (equipment and manpower) to open and then reclose/reseal the capping system along with tools to measure the silo depth and to roughly assess column and silo condition below the capping system. Each bridge with siloed columns may require an individual in-depth inspection procedure.

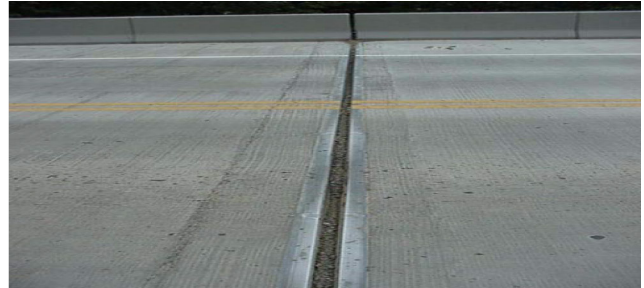
This element defines an expansion joint that uses a neoprene type waterproof gland with steel extrusion or other system to anchor the gland. The steel extrusion is anchored into the concrete deck or header. The quantity should equal the length measured along the expansion joint.

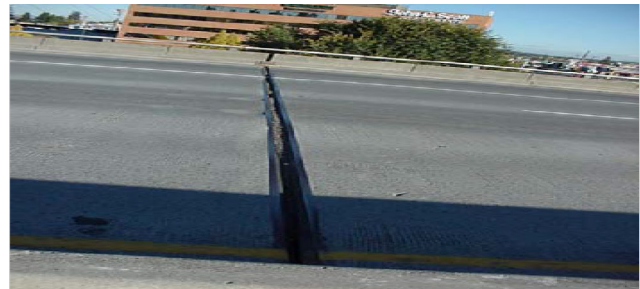
This element defines an expansion joint that uses a neoprene type waterproof gland with steel extrusion or other system to anchor the gland. The steel extrusion is welded to a preexisting steel expansion joint. The quantity should equal the length measured along the expansion joint.

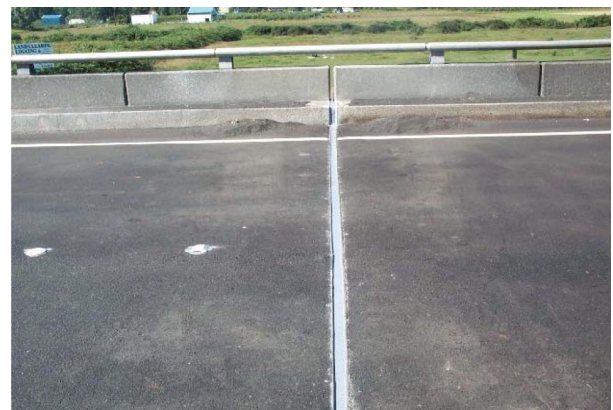
WSDOT BMSE	Prior BMS	Compression Seal/Concrete Header	Units - LF	NBE	BME	ADE
302A	404			--	302	Y

This element defines a joint with concrete headers formed during the original construction of the bridge. The joint is filled with a pre-formed compression type seal. The quantity should equal the length measured along the expansion joint.

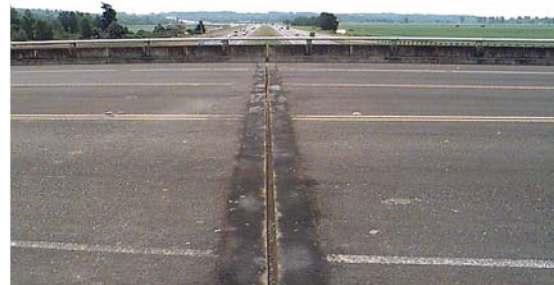
This element defines those joints that have been rehabilitated with a polymer header and filled with a pre-formed compression type seal. The quantity should equal the length measured along the expansion joint.

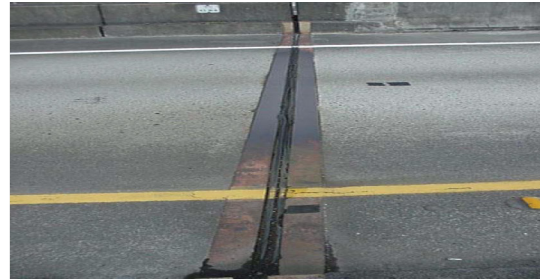
This element defines a joint with steel angle plate headers that have a pre-formed compression type seal. The quantity should equal the length measured along the expansion joint.

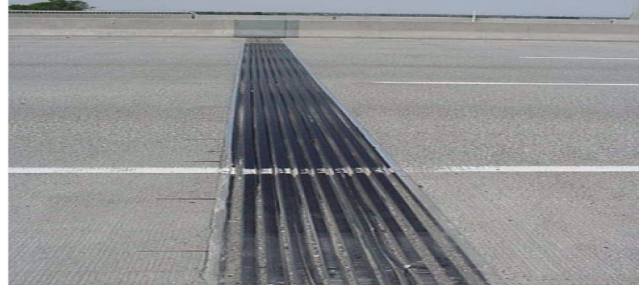
This element defines a large movement joint that has an assembly mechanism with multiple neoprene type waterproof glands. The quantity should equal the length measured along the expansion joint.

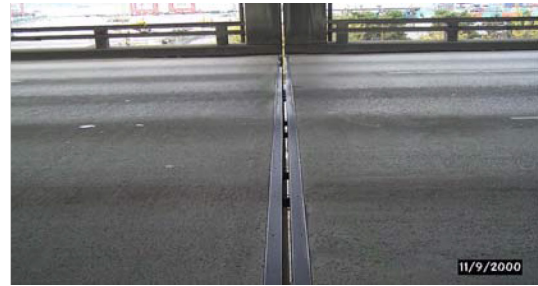
This element defines an open joint with steel angle plate headers. The quantity should equal the length measured along the expansion joint.

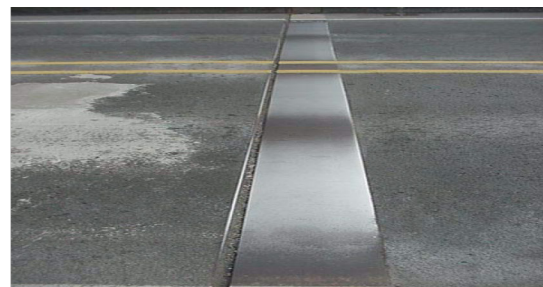
This element defines a joint with steel sliding plates. The quantity should equal the length measured along the expansion joint.

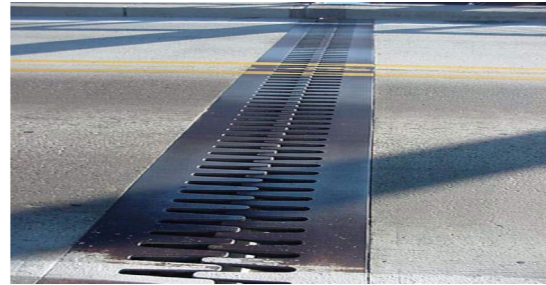
This element defines a joint with open steel fingers. The quantity should equal the length measured along the expansion joint.

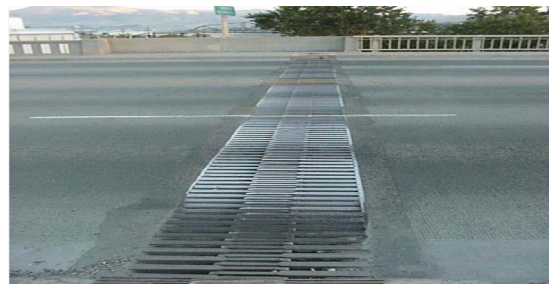
This element defines a joint with bars or plates welded to the steel finger plates to accommodate an overlay. The quantity should equal the length measured along the expansion joint.

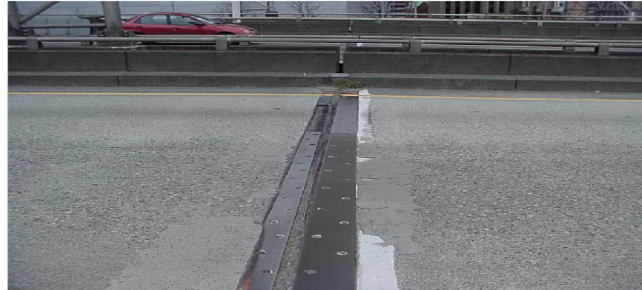
This element defines a bolted sliding plate expansion joint that uses steel springs. The quantity should equal the length measured along the expansion joint.

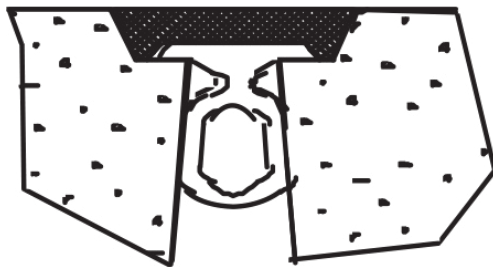
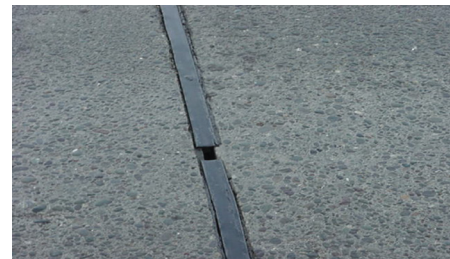
This element defines a joint formed to accept a Bulb-T preformed seal. The seal may be missing, or other materials present to provide a seal. The quantity should equal the length measured along the expansion joint.

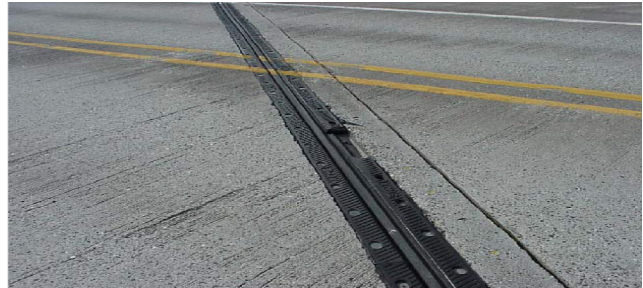
This element defines an expansion joint that uses a waterproof gland that is held in place by molded rubber panels that are attached with bolts. The quantity should equal the length measured along the expansion joint.

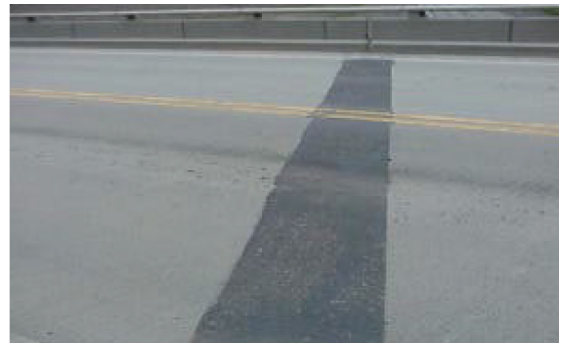
This element defines an expansion joint that has been replaced with an asphalt plug system. The quantity should equal the length measured along the expansion joint.

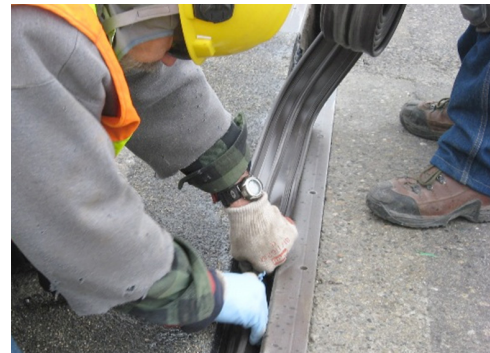
WSDOT BMSE	Prior BMS	Joint Paved Over - Smart Flag	Units - EA	NBE	BME	ADE
308	420			--	--	Y

This element identifies when a steel joint system that has been paved over with asphalt. This is a high risk to damaging the steel joint or bridge deck by the paving operations. When this flag is used, a cost for joint work will be included in the next paving contract to correct the problem. Since the joint cannot be inspected, the joint element condition states should remain unchanged (and so noted). Some steel joints may have more than 2.5" of asphalt may not require rehabilitation. The Total quantity will be the sum total length of all joint systems on the bridge.

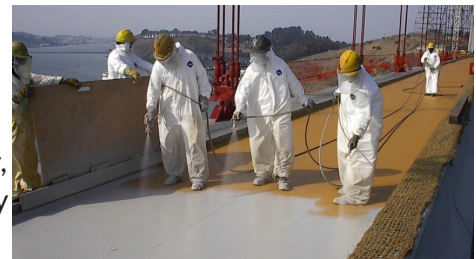
This element is defined as asphaltic concrete overlay with a higher quality waterproof membrane on a bridge deck. These membranes are spray-on polymers that cover rough surfaces or bridge decks that are considered significant. The condition states are based on the overlay, not the membrane. The quantity should equal the overlay width times the length.
