WAHKIAKUM COUNTY FERRY TERMINAL PROJECT

**UNDERWATER SOUND LEVELS
ASSOCIATED WITH DRIVING STEEL
PILES AT THE WAHKIAKUM COUNTY
FERRY TERMINAL**

March 2010

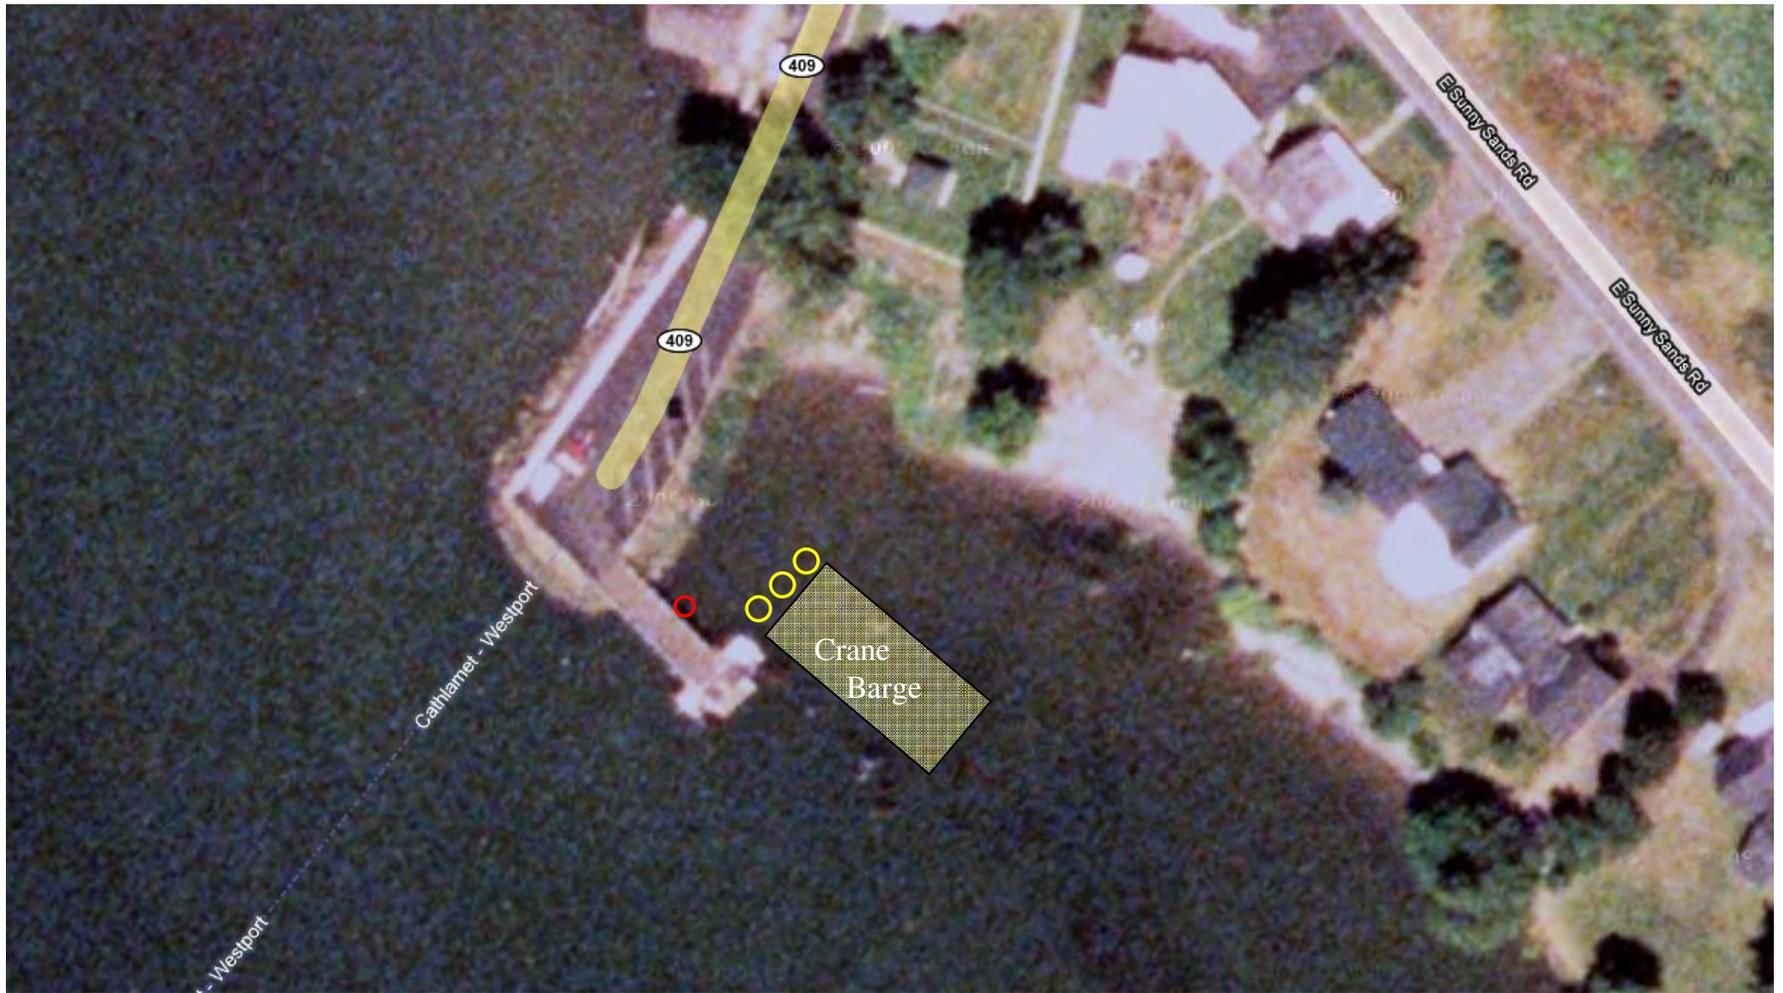
Figure 2: Approximate location of test piles at the Wahkiakum ferry terminal. ○ = Steel Pile; ○ = Hydrophone

The five piles were driven in three locations using a vibratory hammer first. Then an impact hammer was used to drive the pile the remainder of the way and a second pile was welded to the top of the first and then continued with impact driving. The water depths are dependent on tidal flux. The mitigation strategy used was a confined bubble curtain constructed by the contractor. The confined bubble curtain consisted of a single bubble ring at the bottom with a nylon sheath surrounding the ring at the bottom and extending up through the water to about 2 or 3 feet above the water line (tidal dependent). Piles were driven with and without the bubble curtain to determine baseline unmitigated noise levels. Figure 1 shows project area and Figure 2 shows the locations of monitored piles.

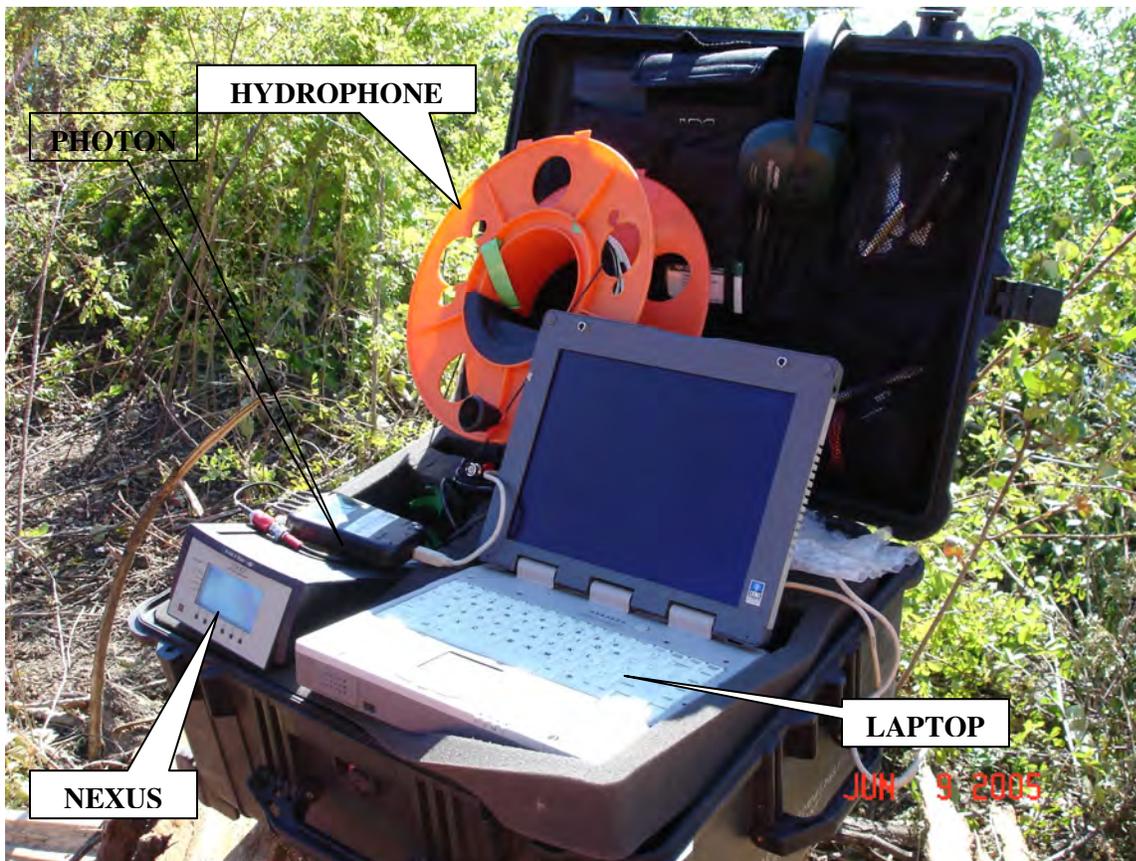
Underwater sound levels were measured near the pile (nearfield) using one Reson TC 4013 hydrophone deployed on a nylon cord between the pile and the ferry access bridge. The hydrophone was positioned at mid-water level. The hydrophone was located at a distance of between 11 and 13 meters from the individual pile being monitored. The measurement system includes a Brüel and Kjær Nexus type 2692 4-channel signal conditioner, which kept the high underwater sound levels within the dynamic range of the signal analyzer (Figure 3). The output of the Nexus signal conditioner is received by a Dactron Photon 4-channel signal spectrum analyzer that is attached to an Itronix GoBook II laptop computer (Figure 3).

Figure 3: Near field acoustical monitoring equipment
