**Engineering Error
Highway Construction Project**

**Report to Transportation Committees
RCW 47.01.490**

Project Title: I-5 Seneca St Vic to SR 520 – Mobility Improvements

Change Order Number: 48, 50R1, 53, 54, 57, 60R2, and 62R2

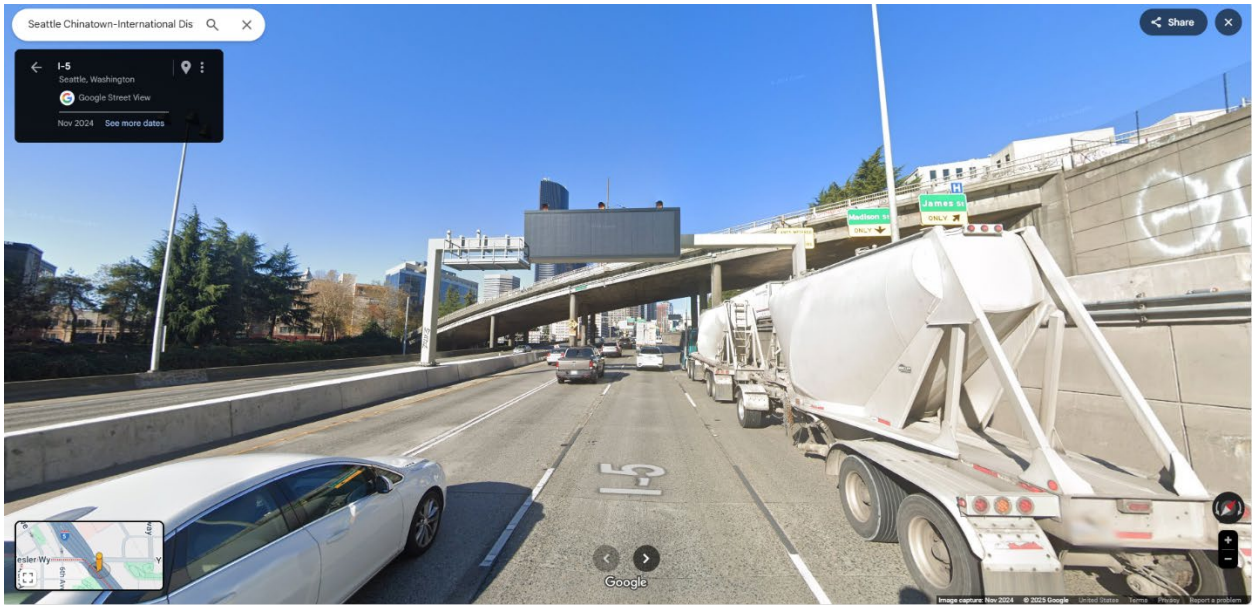
Sign Bridge 1 Location Detail

- The designed span of Sign Bridge No. 1 was too long to fit existing field conditions. In addition, the original design did not consider the ground elevation difference between northbound and southbound I-5. As a result, new plans were issued to increase the size of the west sign bridge foundation and associated barrier transitions.

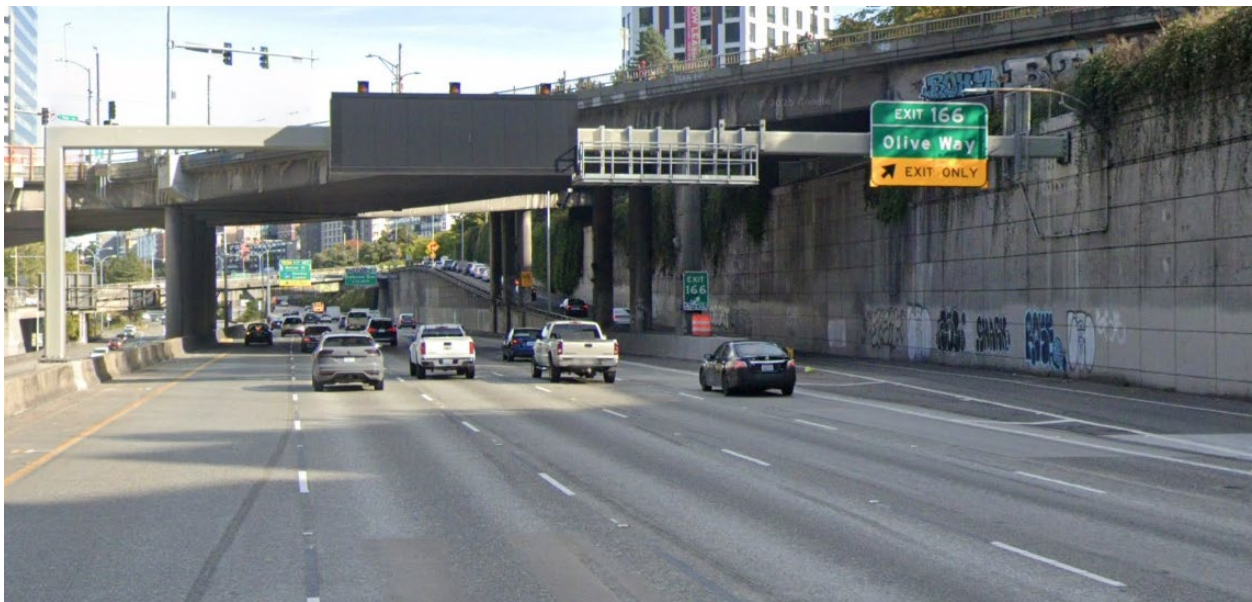
Sign Bridge 3 Location Detail

- The original design of Sign Bridge No. 3 did not consider the curvature of the wall for the planned mounting location of the sign bridge. As a result, the already fabricated sign bridge needed to be modified to account for that wall curvature.

- Sign Bridge No. 3 was designed to be attached to an existing wall. The structural elements of this wall were not in the location identified in the plans. As a result, additional steel reinforcement, design and plan changes were necessary to ensure the wall could bear the added weight of the sign bridge.

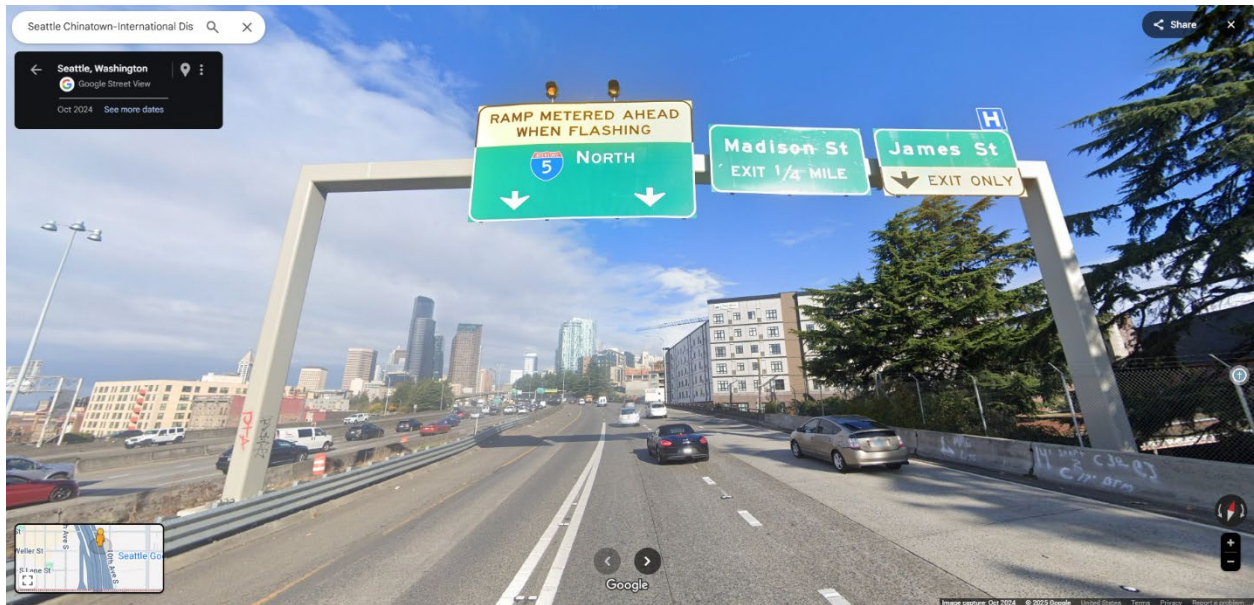
Sign Bridge 8 Location Detail

- The contractor discovered an unknown utility that conflicted with the planned location of the east foundation of Sign Bridge No. 8. This utility was not identified in existing plans and WSDOT has been unable to determine the utility owner.
- WSDOT determined that the cost of re-fabricating a new sign bridge and moving the foundation was more economical than relocating the utility duck bank. WSDOT subsequently provided the contractor with redesigned plans for Sign Bridge No. 8.
- The issues described above resulted in significant delays to the project schedule while the contractor waited for revised plans and re-fabrication of Sign Bridge No. 8.
