Bank Stabilization with Fabric Encapsulated Soil Lifts (FESL)

Zack Billingsley

Department of Civil and Environmental Engineering

Colorado State University

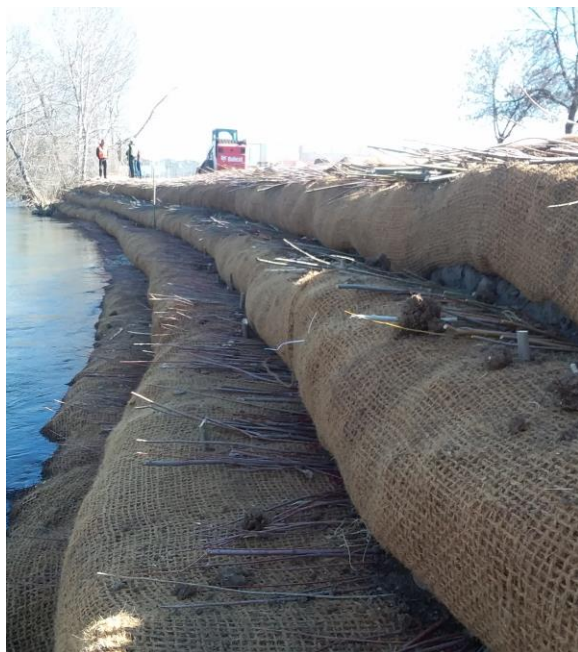
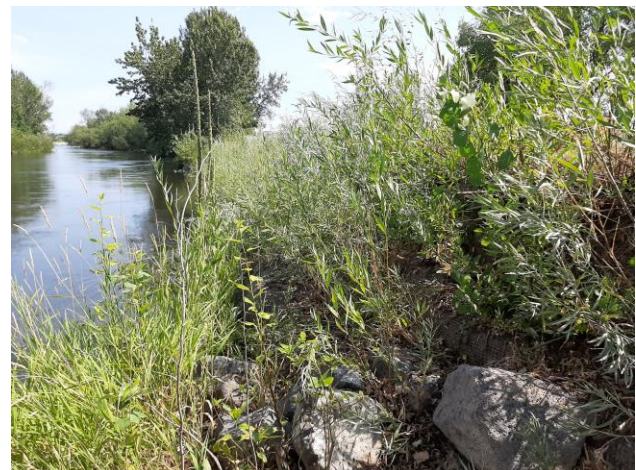
Photographs 1 and 2
Recently constructed FESL along the Boise River (looking upstream). Photos taken March 2019 (left) and August 2020 (right).

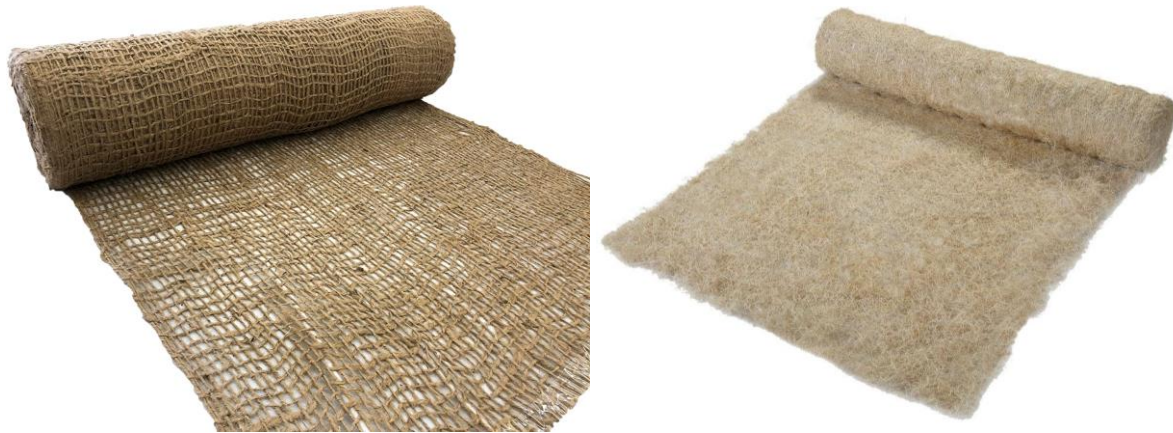
Figure 3: Examples of Coarse (left) and Fine (right) Biodegradable Geotextiles

The outer geotextile layer is a coir matting (i.e. coconut fiber) product used to provide strength and rigidity to the soil lift. This outer geotextile is responsible for providing pullout resistance against lateral earth pressures in the slope by retaining the soil mass, and for withstanding the shear stresses and velocities within the channel. The coir fibers are slow to degrade, providing between 3 and 5 years of stability for the vegetation to establish. The inner geotextile layer is a coir, jute, or straw netting product used to provide an additional layer of protection, but also to encourage root establishment. This fine geotextile product better holds the soil particles in place, but cannot withstand the higher hydraulic forces, thus requiring the

two layers. On streams where ice damage may occur, outer fabrics (coarse geotextile) with greater tensile strength and abrasion resistance should be evaluated (Karle, 2003).

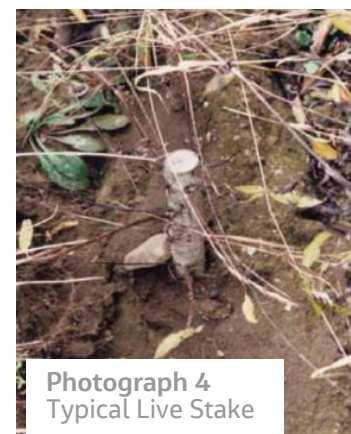
Photograph 4
Typical Live Stake

Live stakes are 1 to 2 inches in diameter and approximately 2-3 feet long cuttings used to stake the geotextile fabric and aid in vegetation establishment. Used in conjunction with dead stakes, the stakes are also responsible for holding the geotextile fabric in place and ensuring the fabric is tight for enhanced performance. Live stakes are inserted throughout the FESL at a specified density dependent on bank slope, environmental conditions, and soil conditions to create the root mass required to bind the soil particles together. Live stakes perform best when installed within the wetted zone of the bank, but may require supplemental irrigation during the first two growing seasons for optimal success. Photograph 4 shows a typical live stake installed in an overbank area to aid in vegetation establishment.

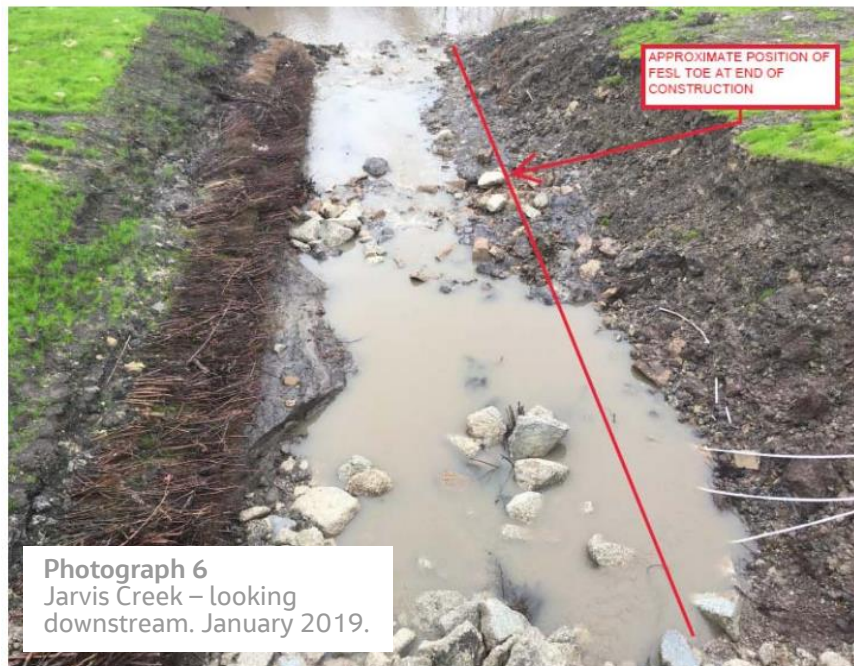
Based on observations and field measurements completed during post-failure site visits, it was determined that there were numerous failure mechanisms that contributed to the failure of the FESL. Certainly, the largest was the storm that swept through the area within 10 days of project completion, however numerous construction-related items that did not follow the design details were also identified. While the right bank completely failed (Photograph 6), evaluation of the left bank showed that the following construction deficiencies also contributed to the failure:

- *FESL ends not adequately anchored / improper keyway.* The complete failure of the FESL along the right bank was the result of an inadequate upstream keyway, that allowed the water to “flank” the FESL and erode the bank behind

The redesign effort for this project (completed December 2020) incorporates a similar design approach but was modified to account for the new topography caused by the severe bed and bank erosion that has resulted from the FESL failure. Construction oversight throughout the entirety of the construction process will be required, which should prevent the same mistakes from occurring again.

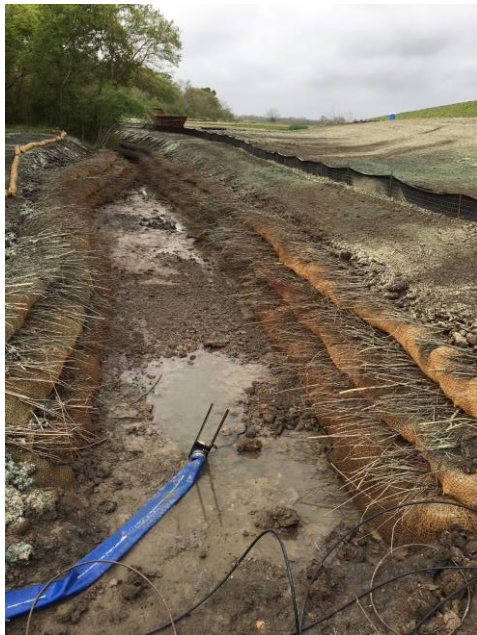
Photograph 8 (Left)

Recently constructed FESL along the Jarvis Creek tributary (looking upstream) – Spring 2018

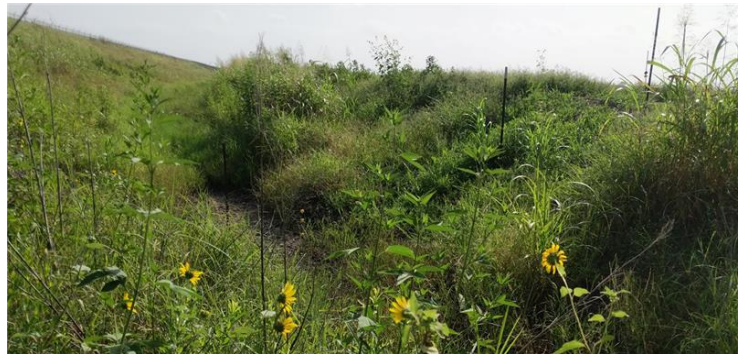
Photograph 9 (Below)

Vegetated FESL along the Jarvis Creek tributary (looking downstream) – Summer 2020

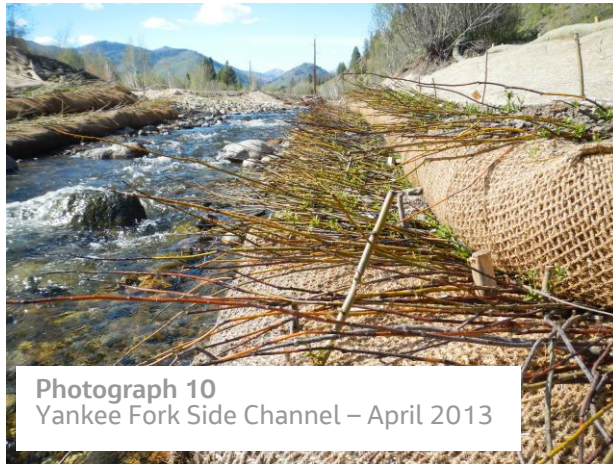
Photograph 10
Yankee Fork Side Channel – April 2013

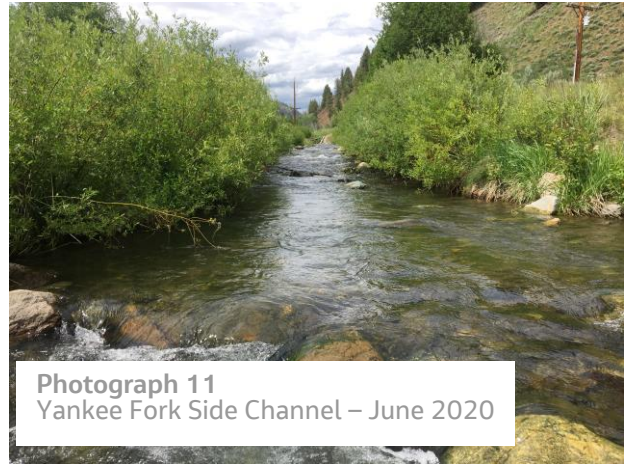
Photograph 11
Yankee Fork Side Channel – June 2020

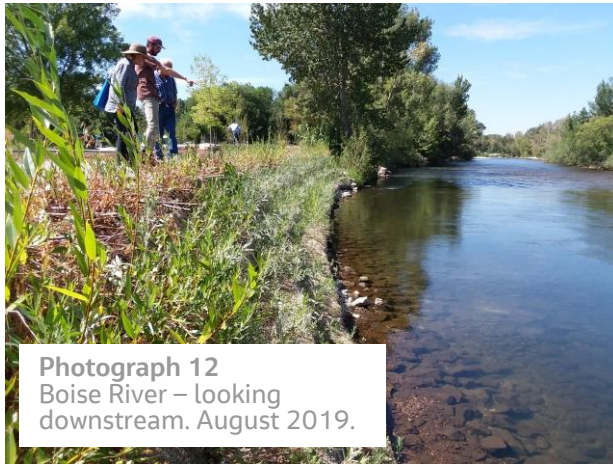
Photograph 12
Boise River – looking
downstream. August 2019.

The FESL toe was set at the summer irrigation flow WSE (~750 cfs) and extended up 6 feet (vertically) to approximately the 25-year WSE at variable slopes (1.5 – 2:1 H:V). Supplemental irrigation was available to aid in vegetation establishment, thus the decision to install the lifts higher along the bank. Since construction completed in March 2019, 7340 cfs (~10-Year Recurrence Interval) has been released (May 2019) and tested the FESL within two months of project completion. This flow resulted in velocities exceeding 5 ft/s and shear stresses exceeding 1.1 lb/ft². Photograph 12 shows the FESL in August 2019, with Photograph 13 showing the FESL in July 2020. Photographs 1 and 2 in Section 1.0 show the same reach of FESL installed at Heron Park looking upstream.

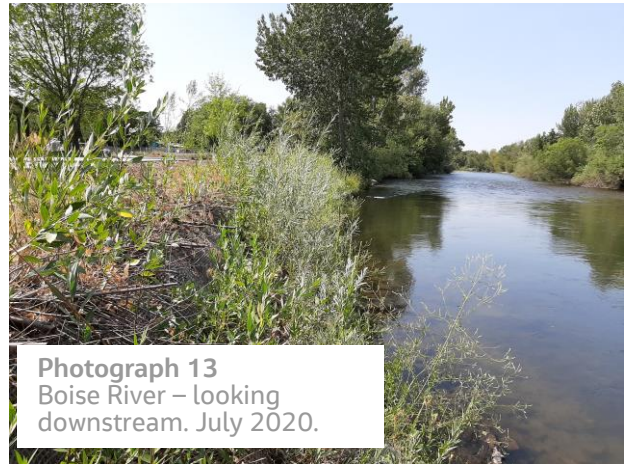
Photograph 13
Boise River – looking
downstream. July 2020.

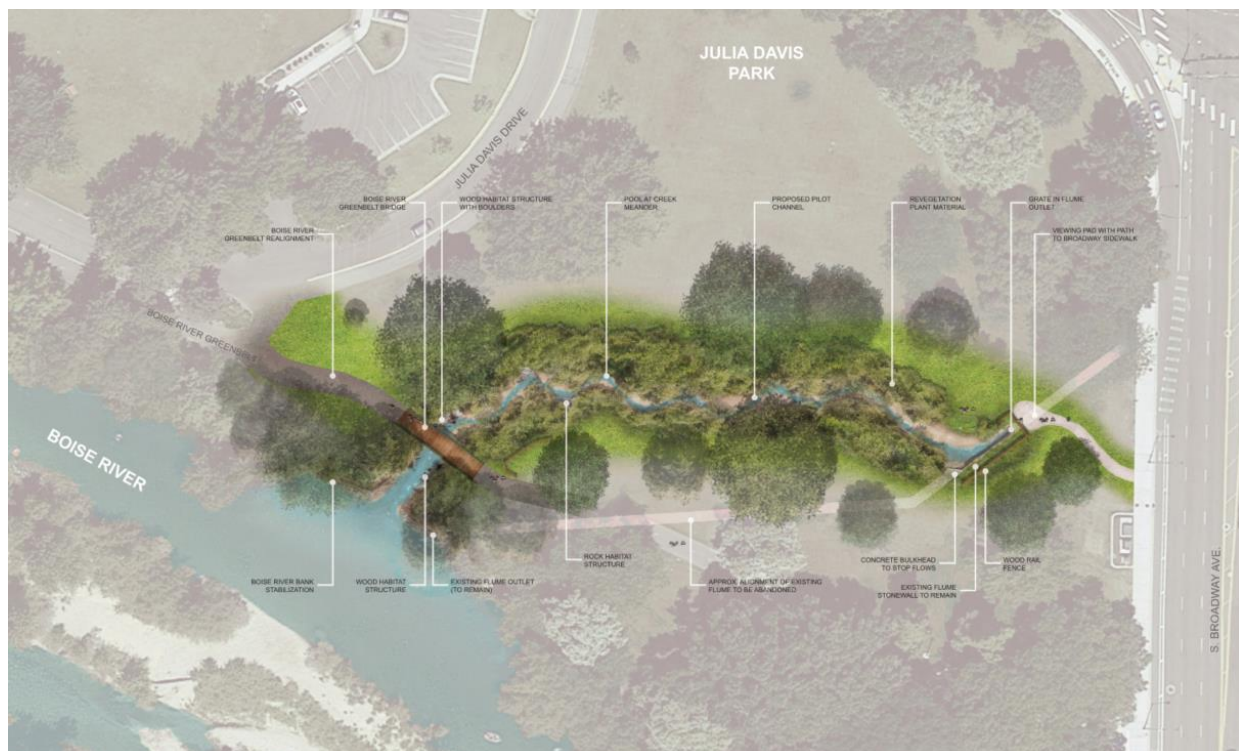
Figure 8: Cottonwood Creek Proposed Rendering

The Cottonwood Creek Daylighting Project is a unique opportunity to restore riparian and aquatic habitat in Julia Davis Park near downtown Boise, by removing the existing underground flume and creating an open channel. Currently, a buried 6' x 4.5' sandstone box flume approximately 400' long (exact length unknown) conveys Cottonwood Creek to the Boise River. The proposed project will abandon the existing flume and create a small channel that will provide not only aesthetic benefits to Julia Davis Park, but also hydraulic and ecological benefits to Cottonwood Creek as well as the Boise River (see rendering – Figure 8).

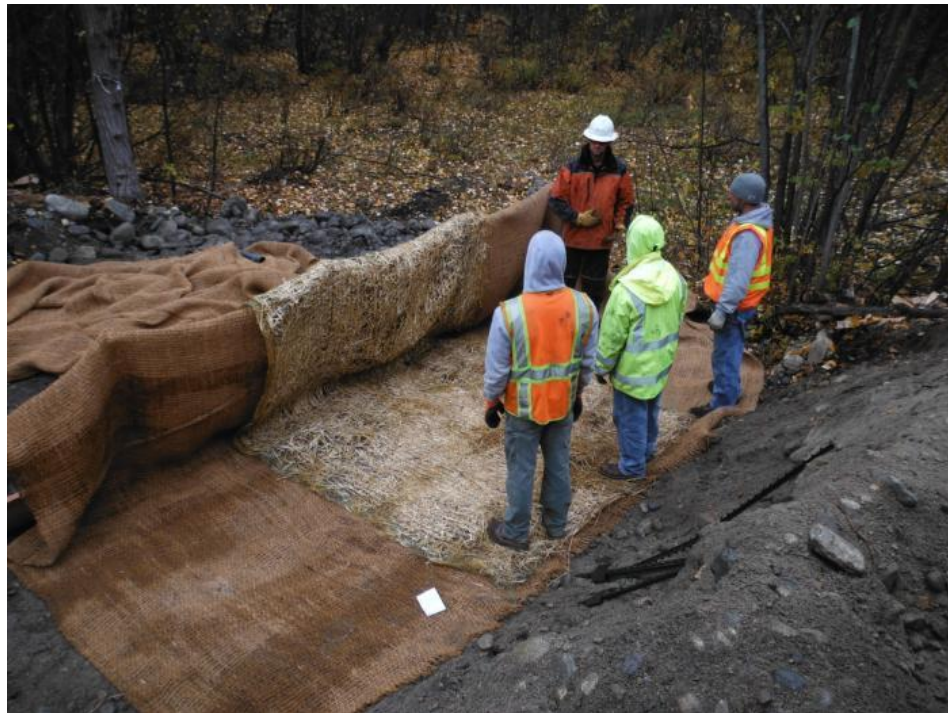
Photograph 1

Preparing FESL lift for backfill. Note the compacted bench below the fabric where the coarse matting is laid down first, followed by the fine erosion control matting inner layer

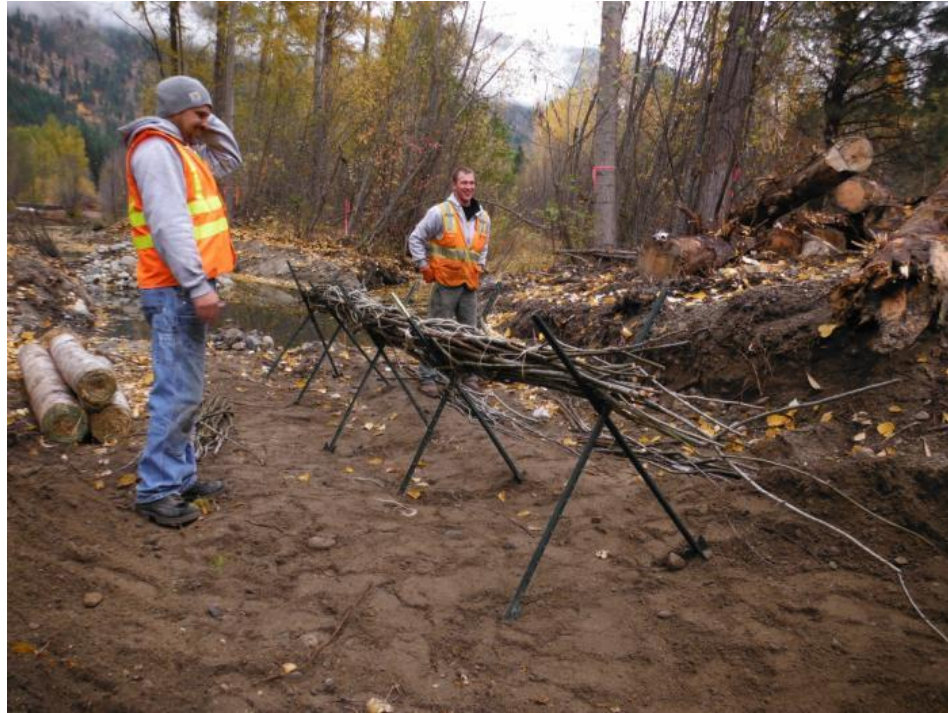
Photograph 2

Preparation of the Live Fascine. When harvesting locally, cuttings should be alive (but preferably dormant) and bound together tightly. Fascines can also be provided already bound when delivered to the site by a supplier.

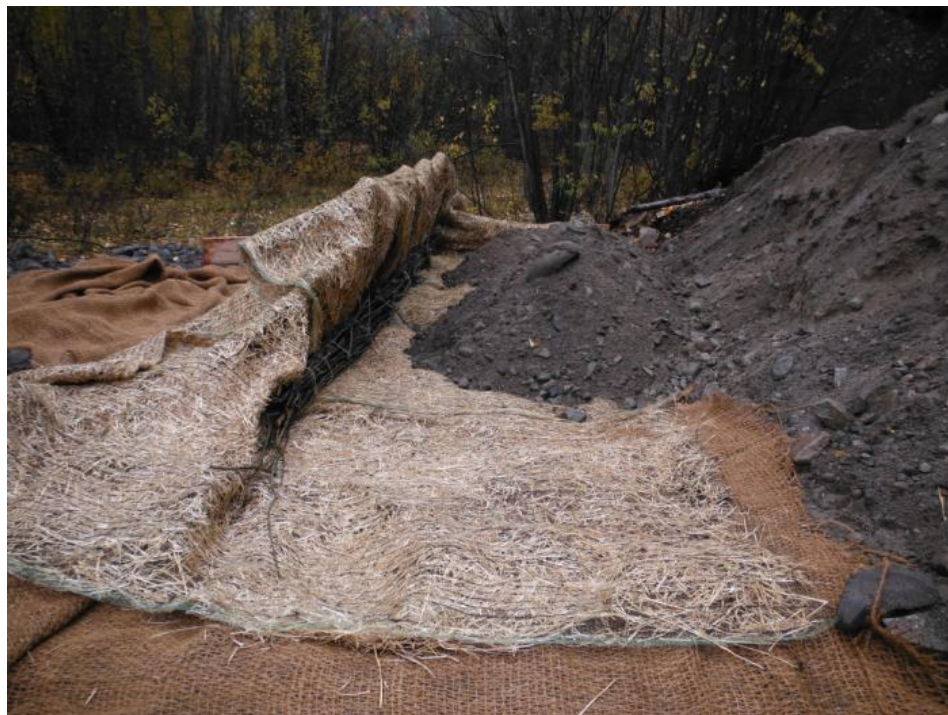
Photograph 3

Backfill of the first lift. Note the two layers of fabric and the Live Fascine bundle at the toe. The backfill should consist of clean native (or imported) backfill material.

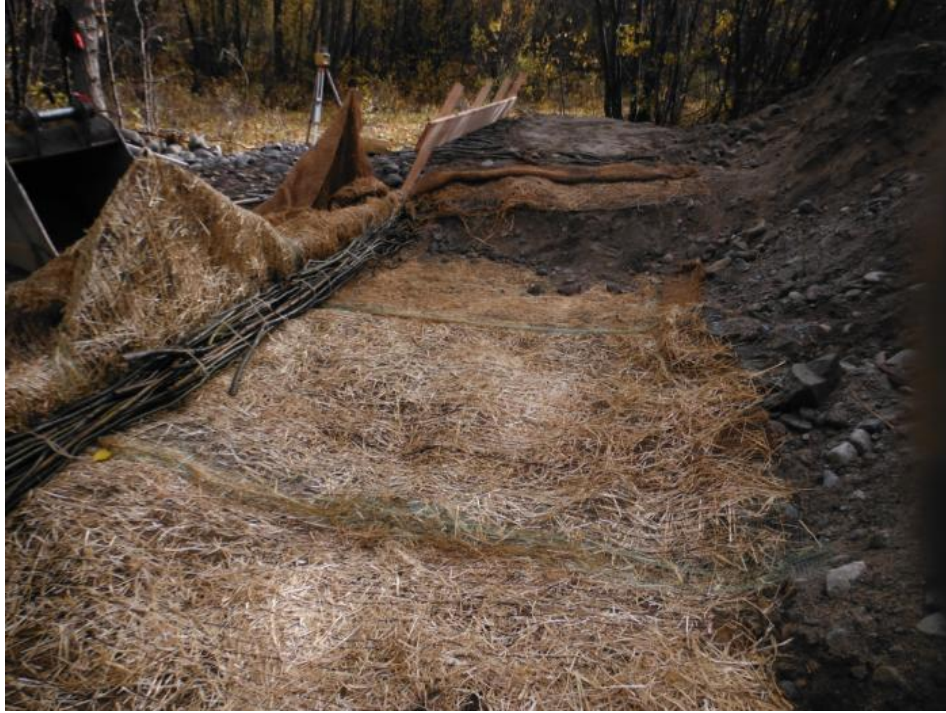
Photograph 4

Construction of the first FESL lift. Forms, such as the wood form in the background, are a common method used to ensure proper construction.

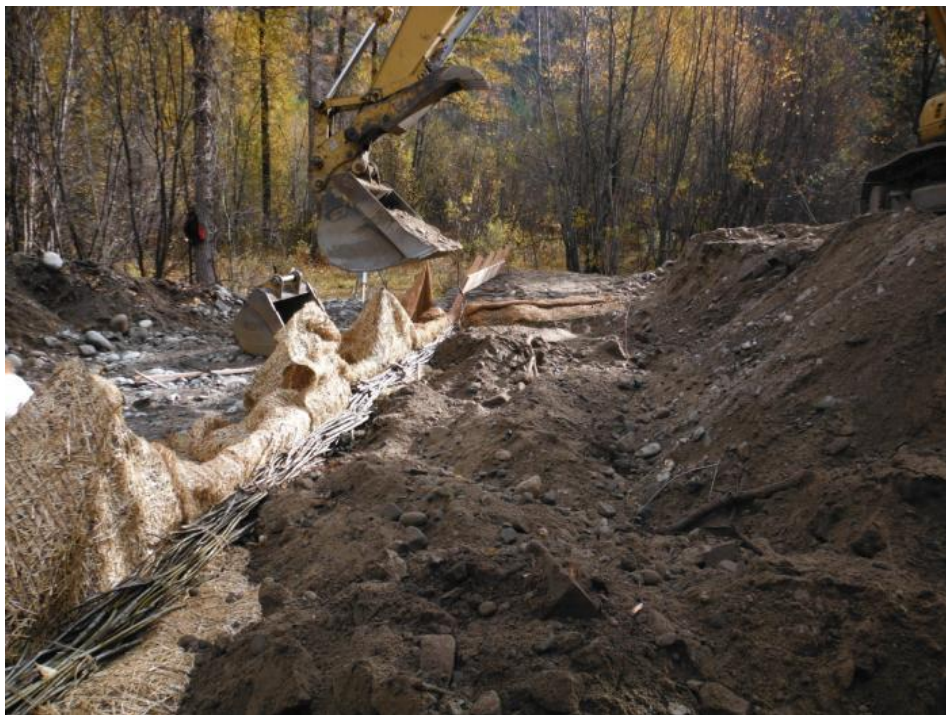
Photograph 5

Continuing construction of the first lift. Backfill of first lift to be compacted to ~85% standard compaction and wrapped with fabric

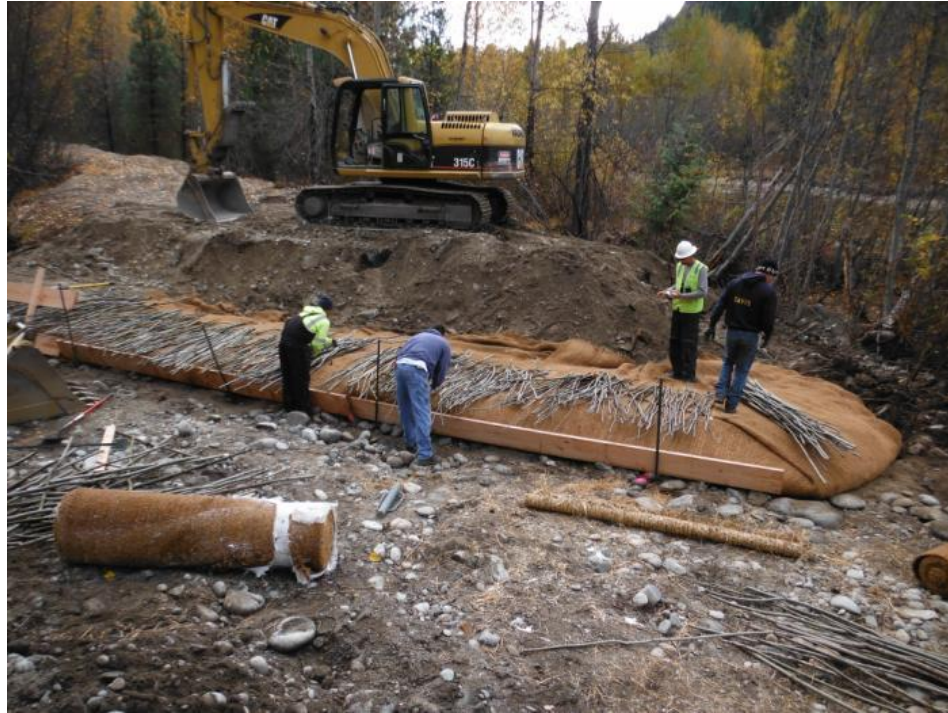
Photograph 6

Completion of the first lift and installation of brushlayer. Note the keyway constructed on the right side of the photo (upstream), with the fabric pulled back as the lift terminates and the fold in the fabric oriented downstream.

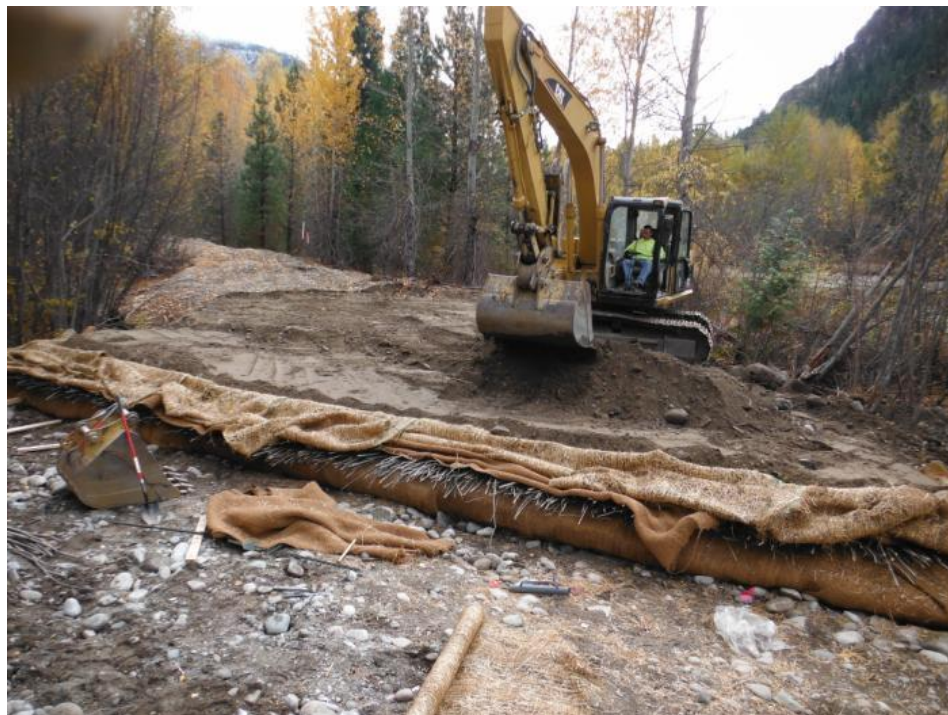
Photograph 7

Construction of Second lift. Note how the excavator is being used for compaction of the soil material.

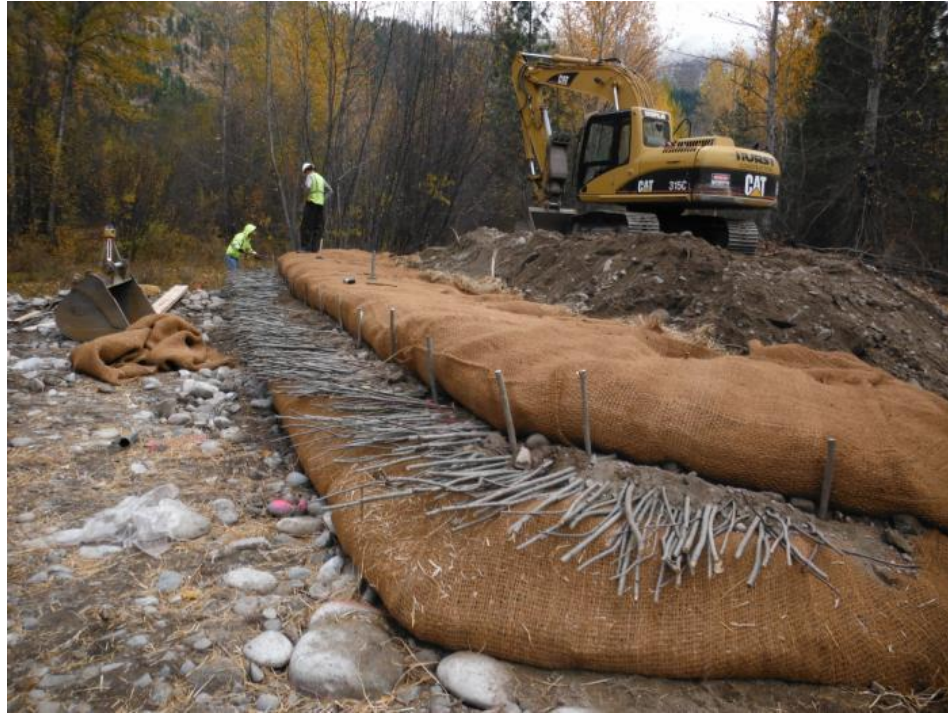
Photograph 8

Completion of second lift and live stakes installed in first lift. Note the soil “sprinkled” on top of brushlayer between the second lift – this aids in root establishment of the brushlayer cuttings.

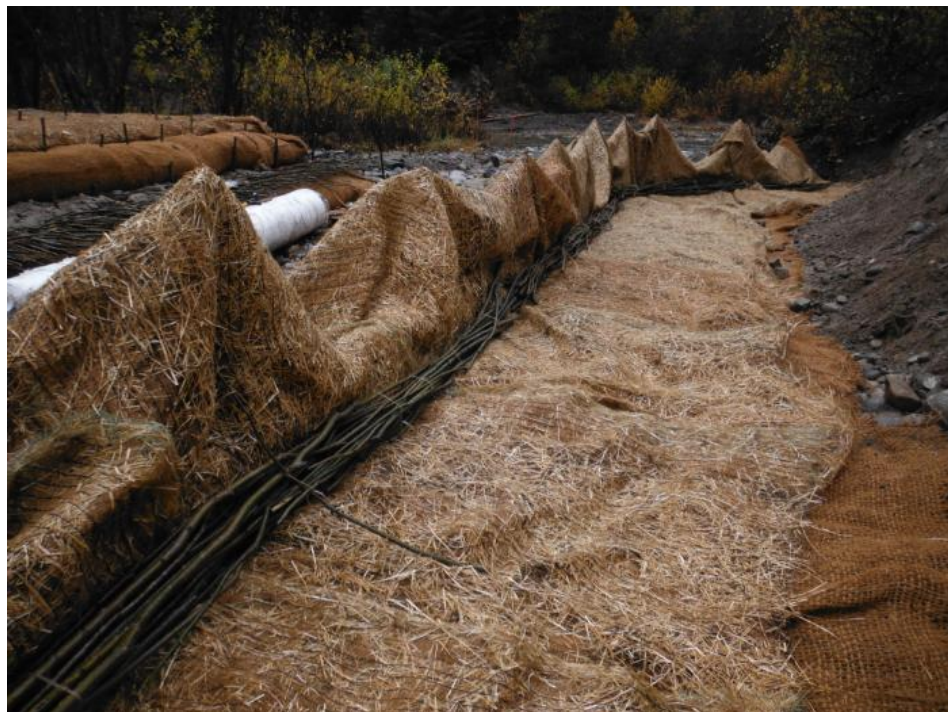
Photograph 9

Preparation of fascine and fabric for the first lift on the opposite (left) bank

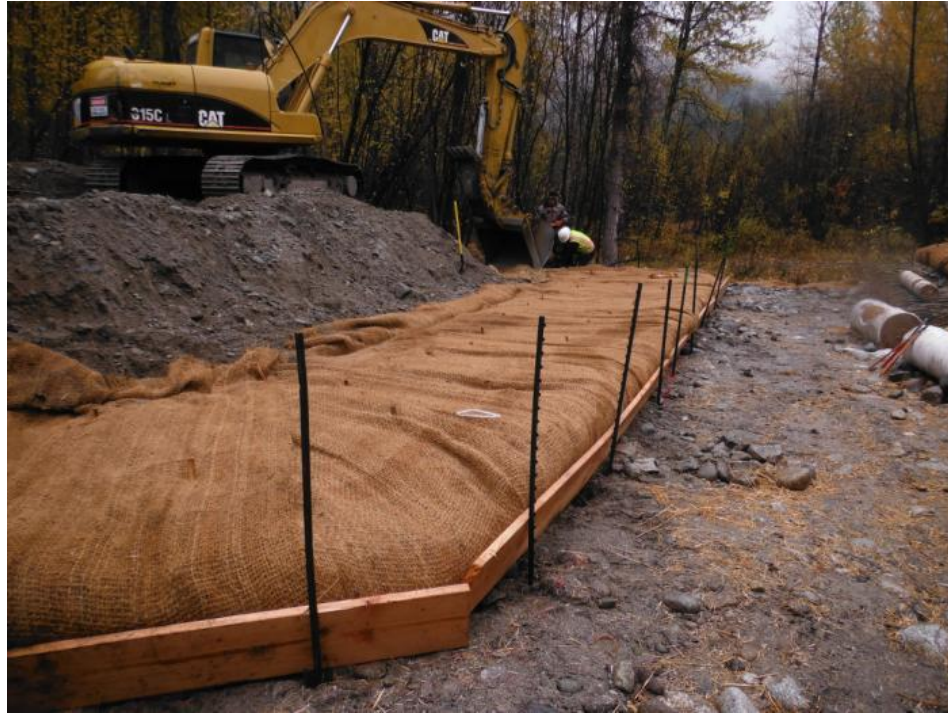
Photograph 10

Completion of first lift on the left bank. Note the method for creating the forms and the stakes (live and dead) installed within the fabric throughout the length of the lift.

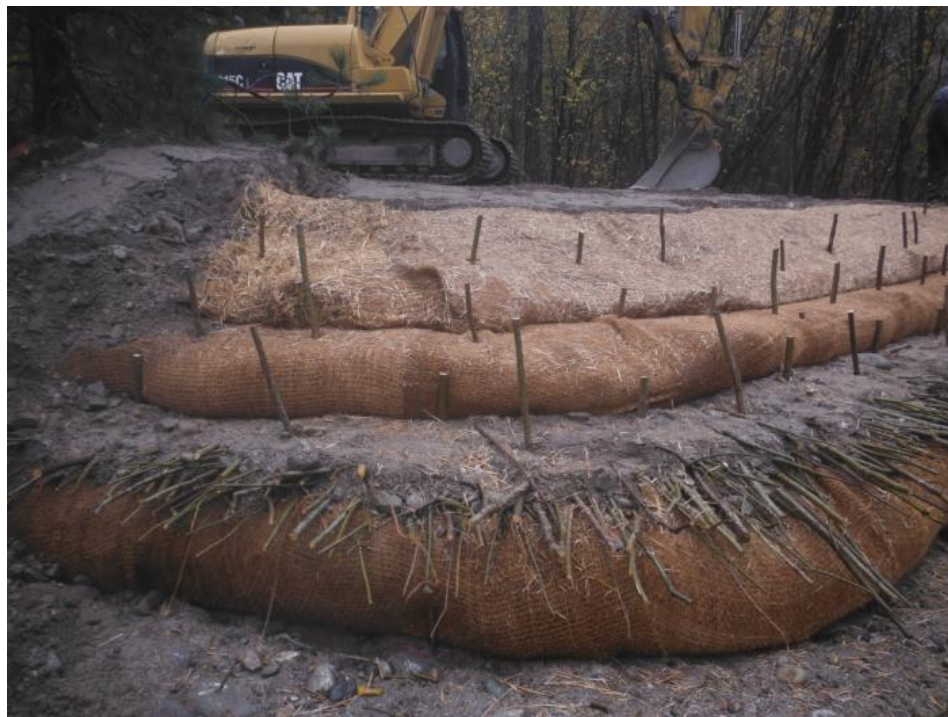
Photograph 11

Completion of first two lifts along left bank with brushlayer and live stake. Additional fabric used for upper slope stabilization above the second lift.

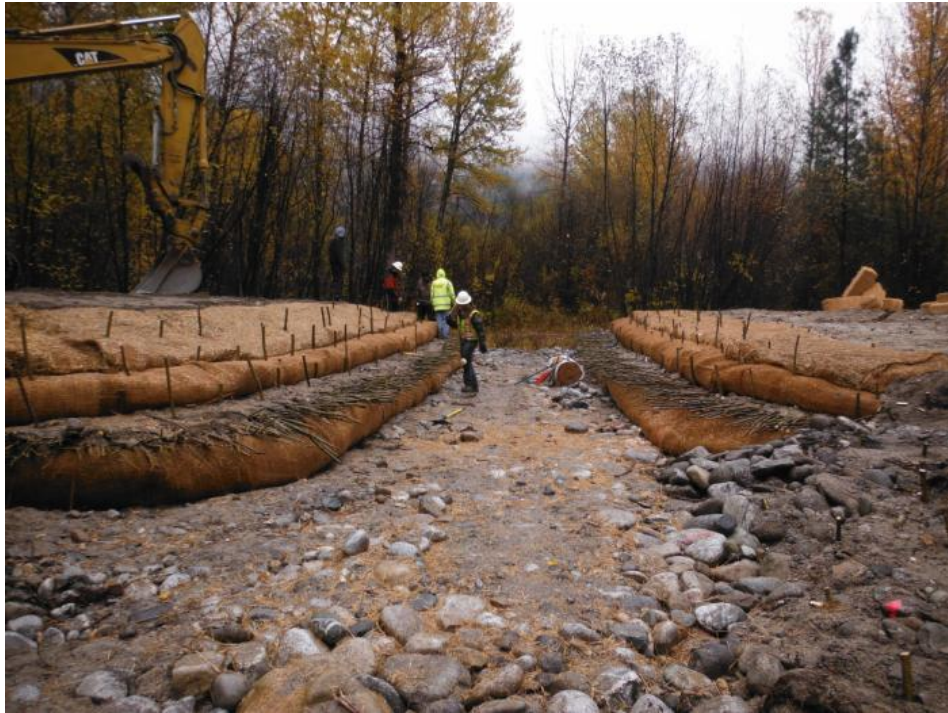
Photograph 12
Completed installation of FESL looking downstream
